CHERNOBYL

Radiation Levels in the Zone

ABOUT ME

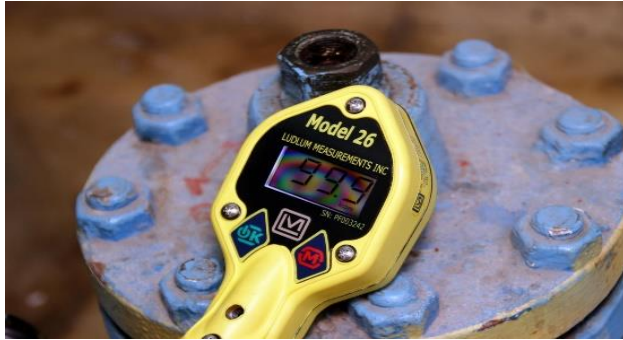
COUNTS PER MINUTE

When conducting field surveys looking for contamination in the environment we used a NaI scintillation detector paired with a Ludlum Model 2350 Datalogging Survey Meter and a Ludlum Model 26 Integrated Pancake Frisker. Both of these units were calibrated to measure radioactive interactions in counts per minute.

The gamma scintillation detector was used to measure gamma fields in and around the Sarcophagus and to detect contamination in the environment.

The Pancake Frisker was used to detect and measure surface contamination by alpha and beta emitting radioactive materials.

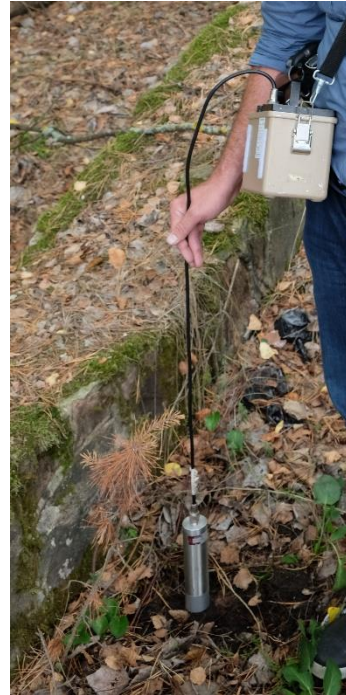
ROENTGEN

uR/hr

While traveling in the zone we utilized multiple methods of dose measurement. In addition to dosimetry provided by ChNPP I also took a CsI dosimeter which datalogs radiation levels and accumulates dose over time. The dosimeter tracks dose over time using the micro-Roentgen as the unit of measure. (1 uSv/hr = 100 uR/hr)

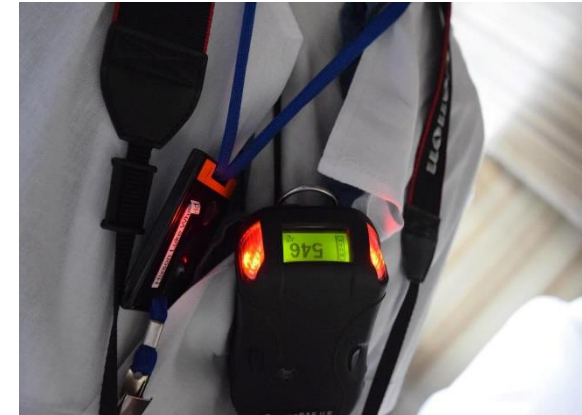
Background in US (2-4 uR/hr)
Background in the Exclusion Zone (4-6 uR/hr)

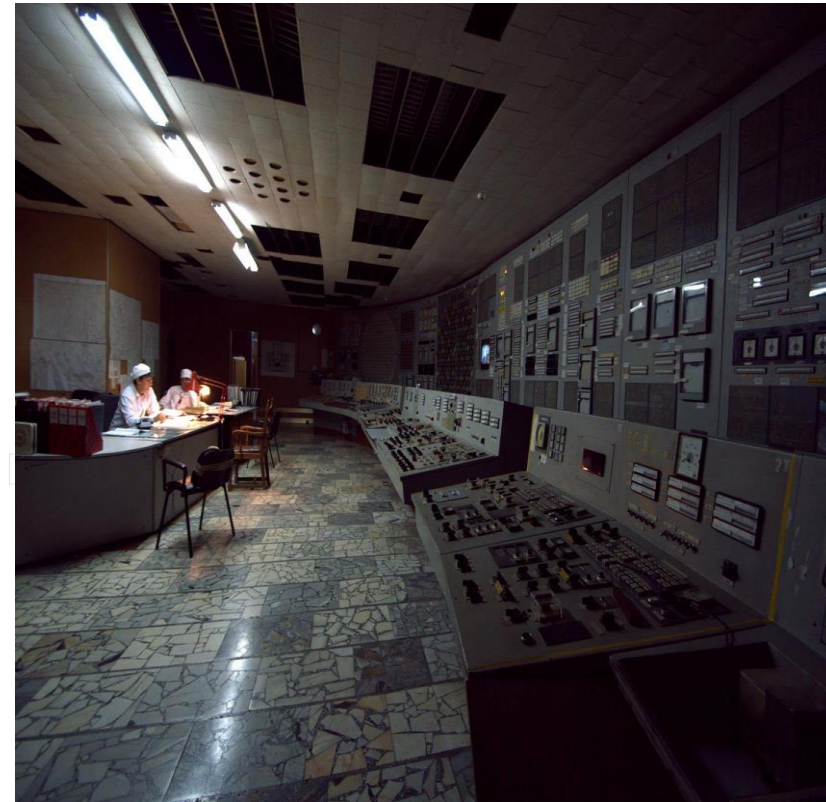
UNIT 2 CONTROL ROOM

Ambient dose rates in the control room ranged between 55 uR/hr and 117 uR/hr.

One area of the ceiling was found to have an elevated dose rate of 458 uR/hr. *This was assumed to be from feedwater lines which used to return coolant from the condensers back to the reactor building during operation.*

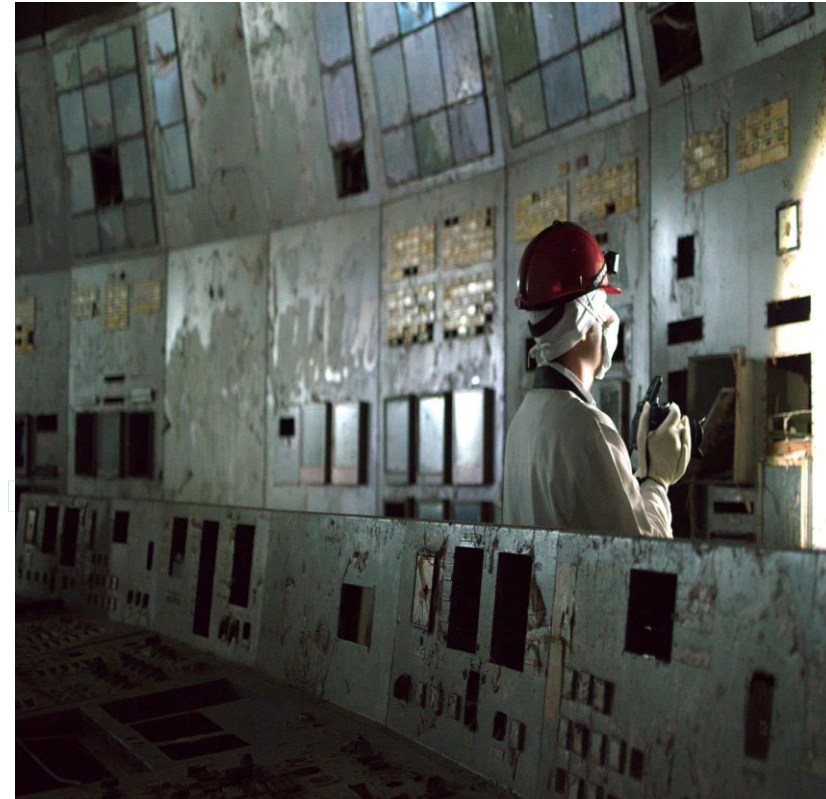
UNIT 4 CONTROL ROOM

Ambient dose rates in the Unit 4 control room ranged between 1,600 uR/hr up to 6,550 uR/hr.

The dose rates in the Unit 4 control room are greatly influenced by the gamma shine coming from the melted nuclear fuel in the reactor building. There are still hotspots of contamination which can be found in the control room, the highest of which was found behind the operators panels.

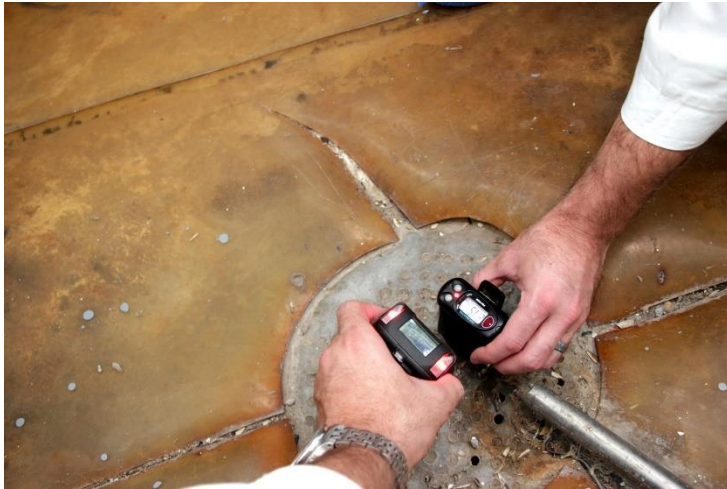
UNIT 3/4 VENTILATION BUILDING

There are many drains and pipes where the gamma fields are over 3,800 $\mu\text{R}/\text{hr}$.

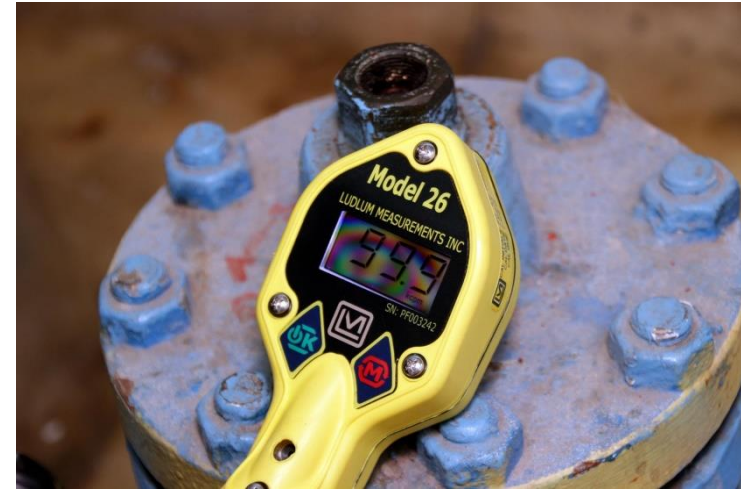
On top of some of the pipes and connections we were still able to detect large amounts of alpha and beta emitting radioactive materials which tended to max out the detectors capabilities.

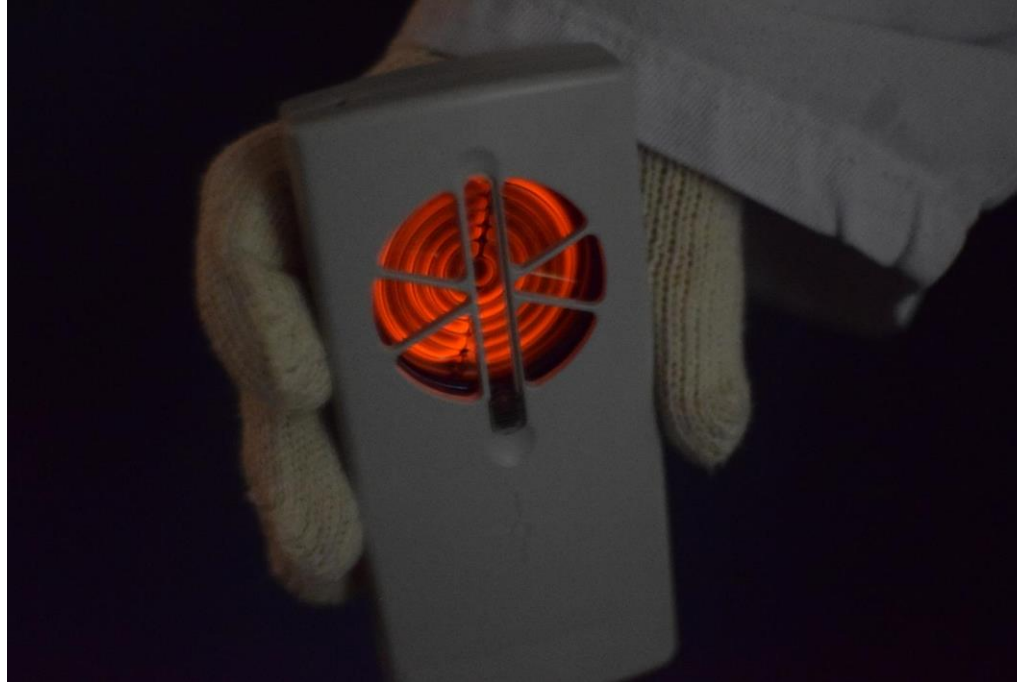
UNIT 3/4 VENTILATION BUILDING

One of our group members brought a new detector that was being beta-tested for the manufacturer. The detector was specifically designed for better detection of beta contamination and operated better in the ventilation building than some of the other equipment in that regard. Some of the levels of contamination were so high that they caused the Geiger-Mueller tube in the device to glow red in the dimly lit rooms.

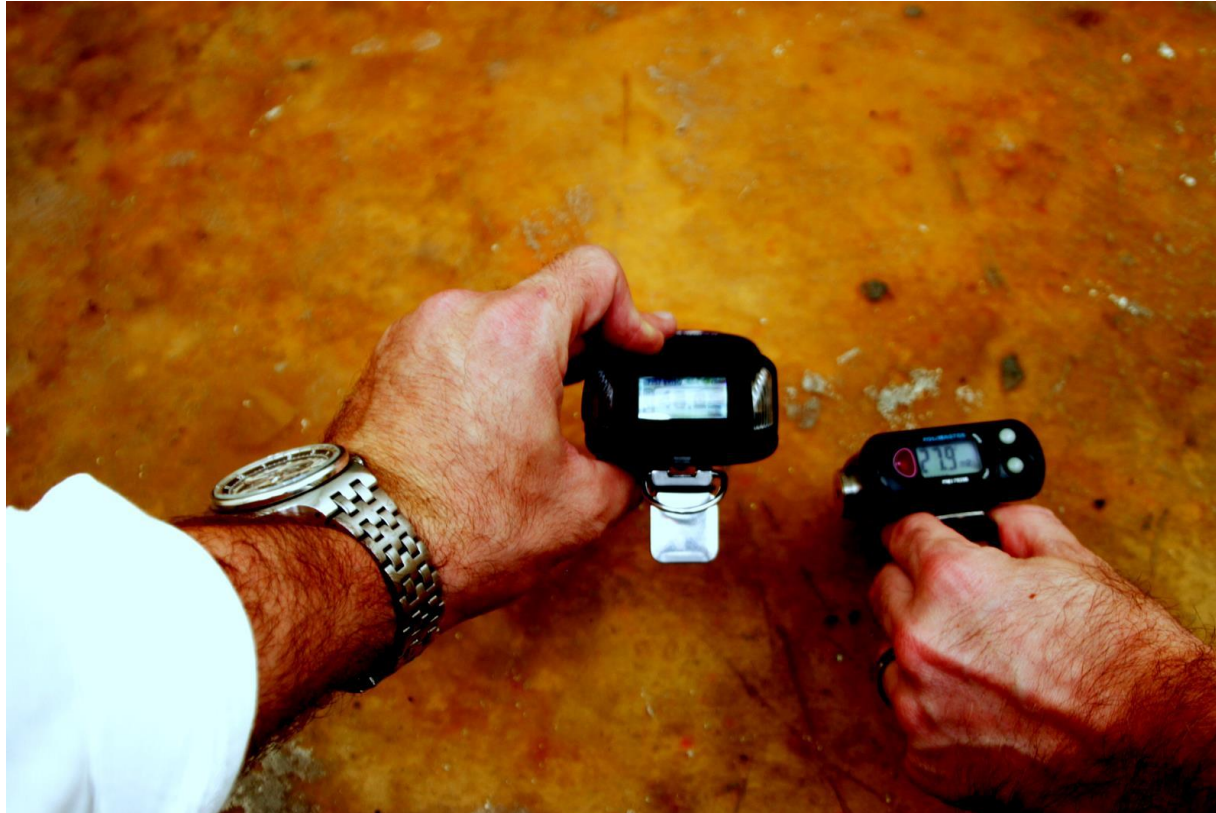
UNIT 3/4 VENTILATION BUILDING

One of the most contaminated areas that we found in the maintenance corridors was a dimly lit stairwell with hotspots of contamination on the floor that contained gamma exposure rates over 48,260 uR/hr (48.26 mR/hr).

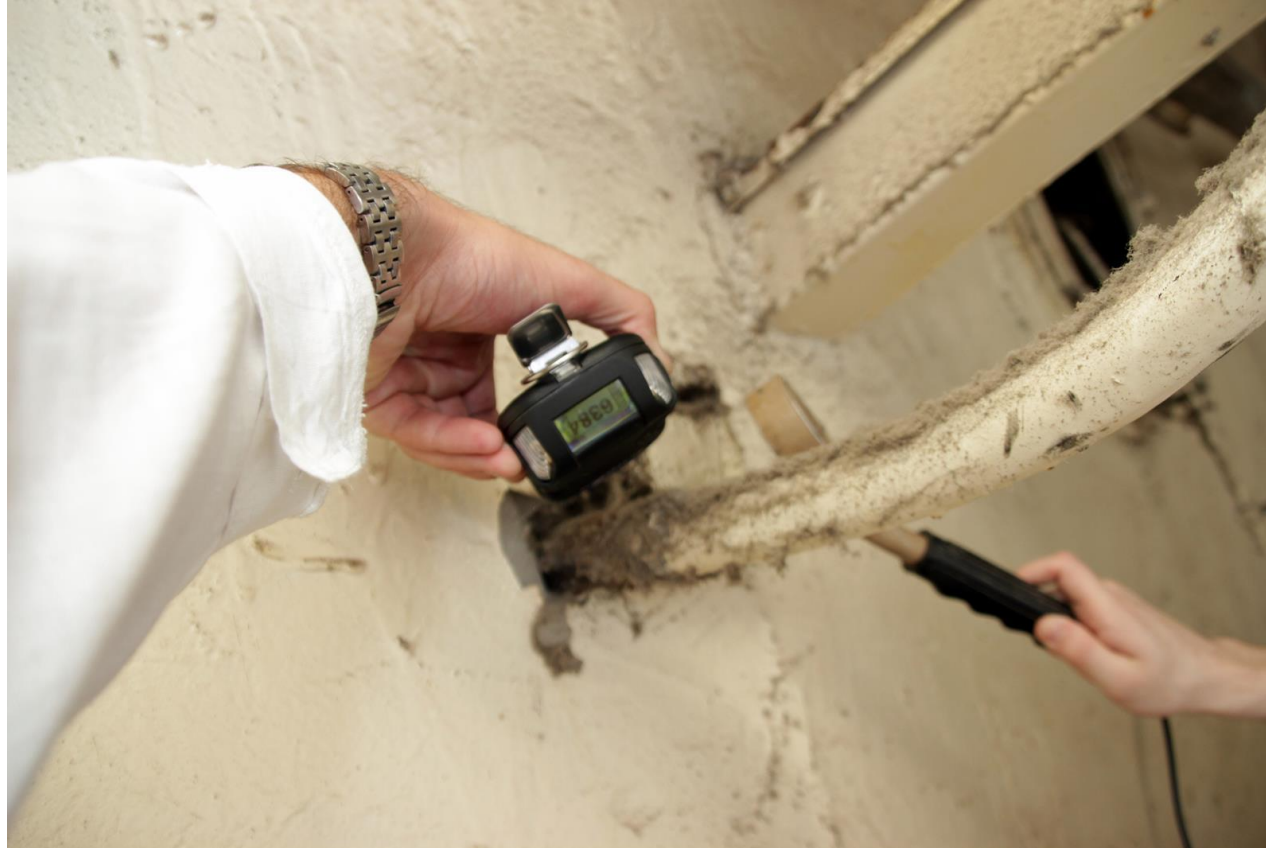
UNIT 3/4 VENTILATION BUILDING

There is a continuing problem of contamination spreading and getting trapped in the dusts in the buildings. We continuously monitored the accumulating dust piles on top of pipes and rafters in the reactor buildings and main circulating pump rooms. We were able to identify areas with large piles of dust which maxed out the pancake detector with alpha and beta particles but where the gamma levels were no where near as high.

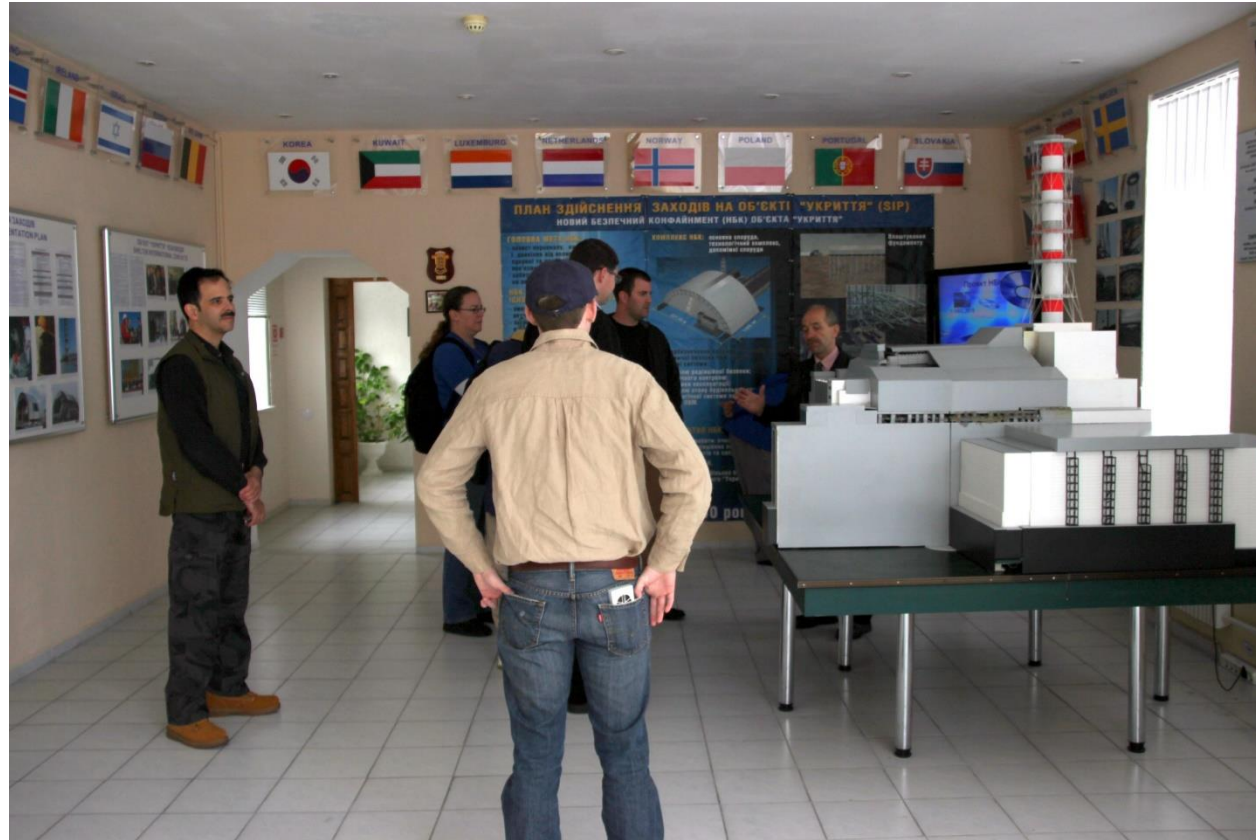
GAMMA FIELDS AT CHERNOBYL

While taking this picture, directly behind me is a large viewing window that is pointed directly at the Unit 4 Sarcophagus. When facing the Sarcophagus with the dosimeter pointing at the structure, the dose rate was 731 $\mu\text{R/hr}$. When my back was turned to the window, the radiation exposure dropped to 61 $\mu\text{R/hr}$. If I walked to the opposite side of the room near the poster the rates dropped to 37 $\mu\text{R/hr}$.

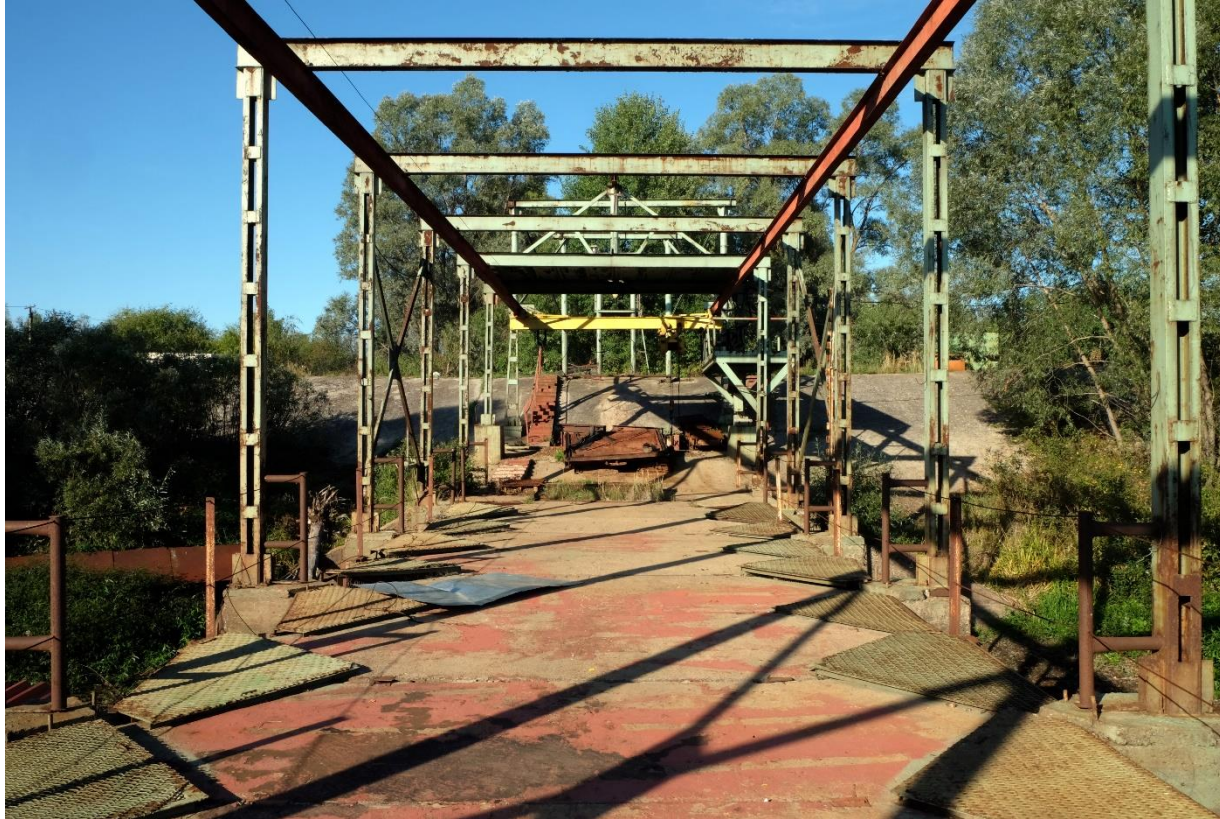
CONTAMINATION IN THE ENVIRONMENT

The Chernobyl Nuclear Power Plant drew coolant from a large man-made lake that was connected to the Pripjat River.

At the site of the water-intake stations, which once drew water into the cooling ponds, we found a hotspot of contamination while looking for fuel fleas in the local environment.

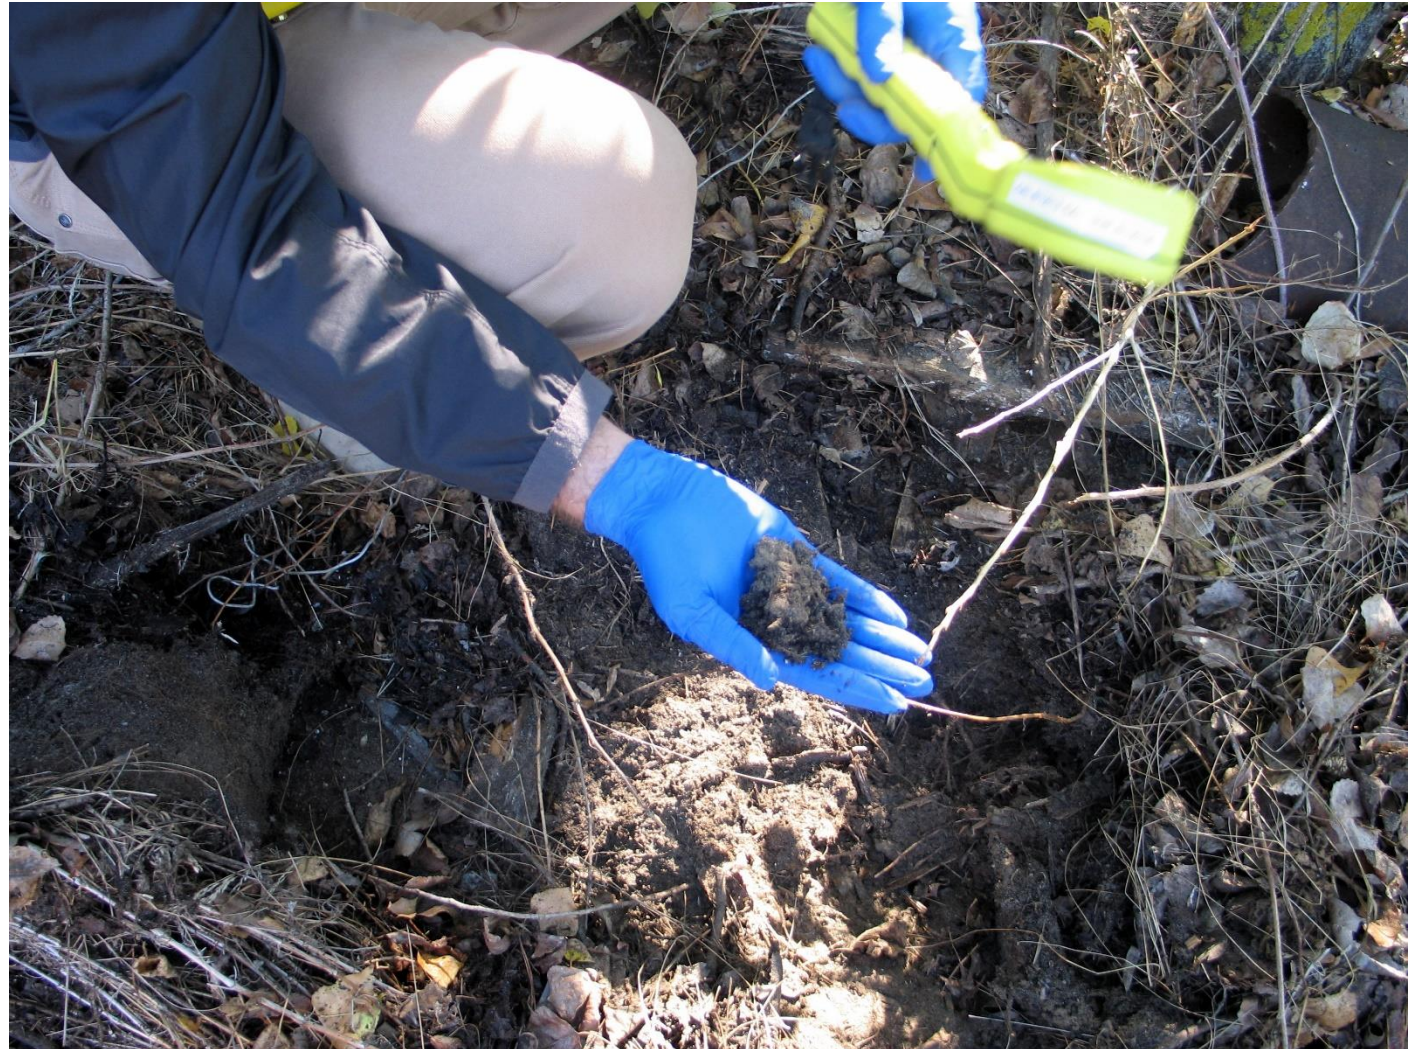
CONTAMINATION IN THE ENVIRONMENT

Isotope	Activity
Am-241	3,782 pCi/g
Ba-133	42 pCi/g
Cs-137	78,274 pCi/g
Eu-154	48 pCi/g
Gd-153	21 pCi/g
Ra-226	384 pCi/g

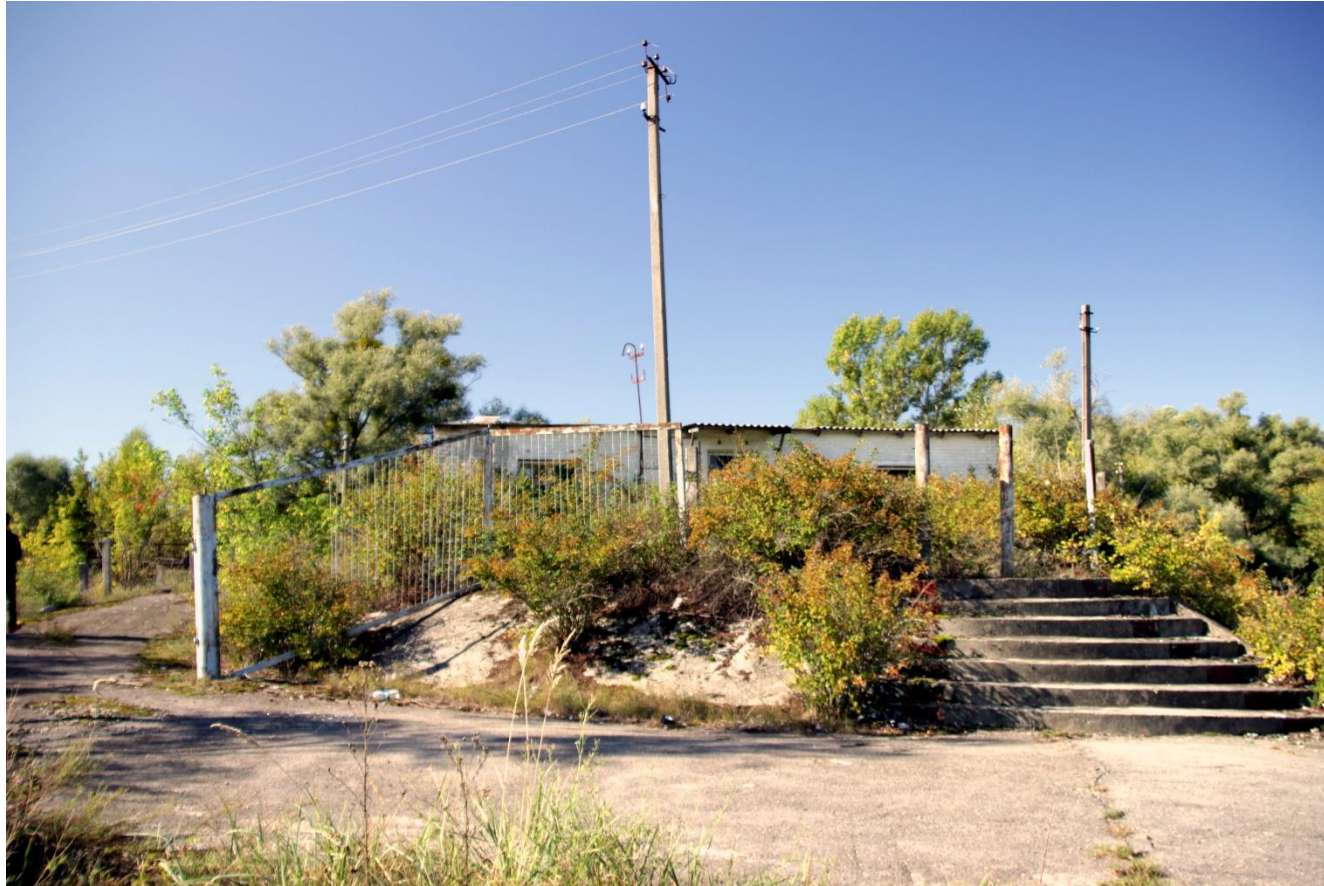
CONTAMINATION IN THE ENVIRONMENT

Chernobyl City is about 10 miles away from the Chernobyl nuclear power plant. Near the docks at the Pripyat River we analyzed a small soil sample where the dose rates were below background (4-6 $\mu\text{R/hr}$ at waist-level).
